### Gediminas Castle Hill, Lithuania, update 2019

NAME: Landslide affecting Gediminas' Castle Hill

YEAR: 2017-19

CLIENT: National Museum of Lithuania

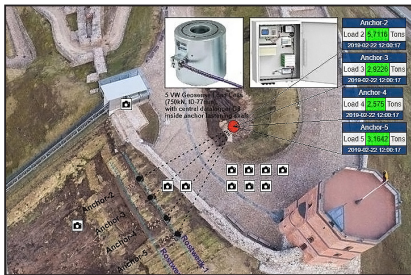
Vista Data Vision - Load Cells

So far, 23 wireless tilt meters have been installed, connected to the Wi-SOS 480 Gateway; 50 prisms are powered with four GeoMax Total Stations and five load cells measure the anchors' load, powered by a Geologger G8-Plus.

Measuring load on anchors.

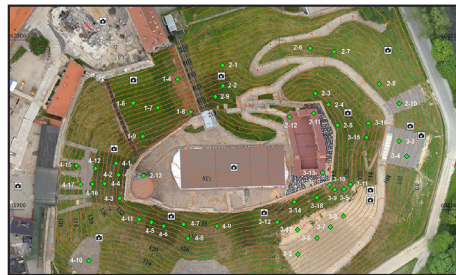
Prisms

For measuring deflection.

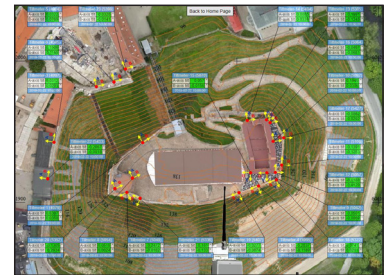
Tilt Meters

Monitor existing retaining walls and landslide.
